Tree Survey
Development Site
Port Road
Killarney
Co. Kerry

Project No. 6620

23 April 2024

DOCUMENT:
6620 – RP04 Tree Survey Report

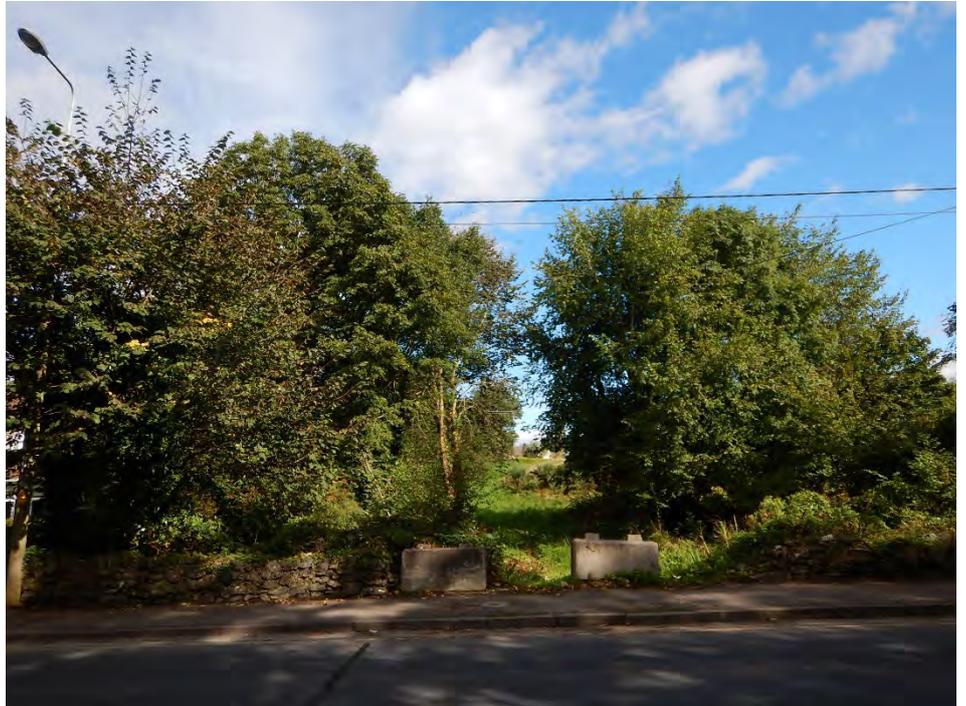
The site is accessed off Port Road in the northwest corner of the site, with the access track passing through a gap in a remnant section of overgrown Elm and Ash hedgerow. This section of old hedge (comprised of trees T31-T36) is in mostly poor condition due to a combination of disease, poor structure, physical damage, and a lack of regular management.

Photo 1. Ash and Elm trees close to the entrance into the site from Port Road

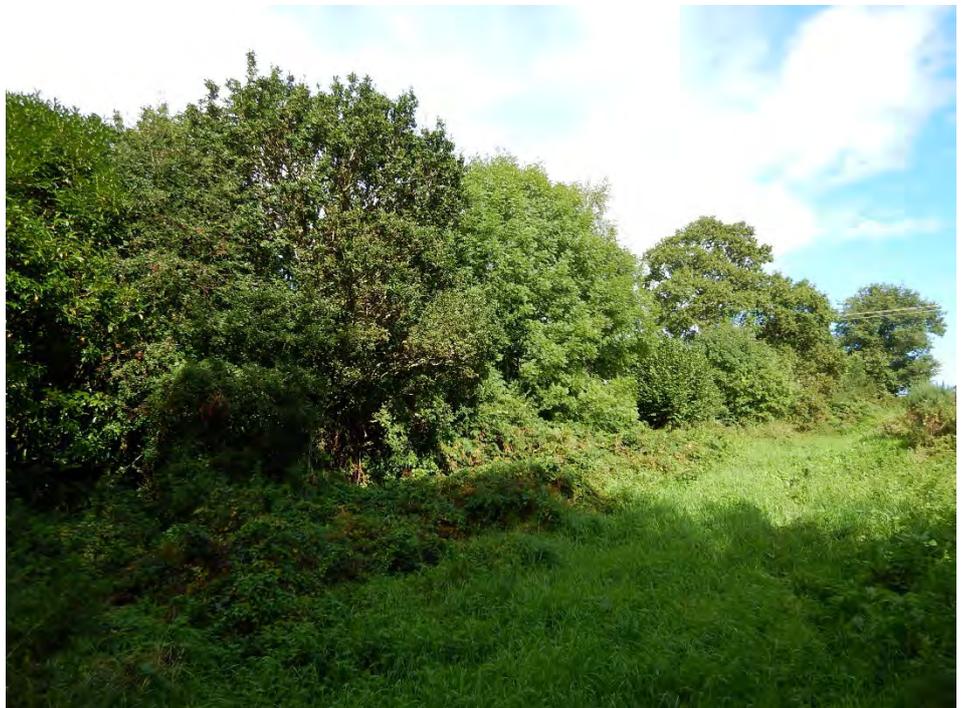
Photo 2. Trees T1-T5 along hedge H1 on the northern boundary of the site, viewed from the west

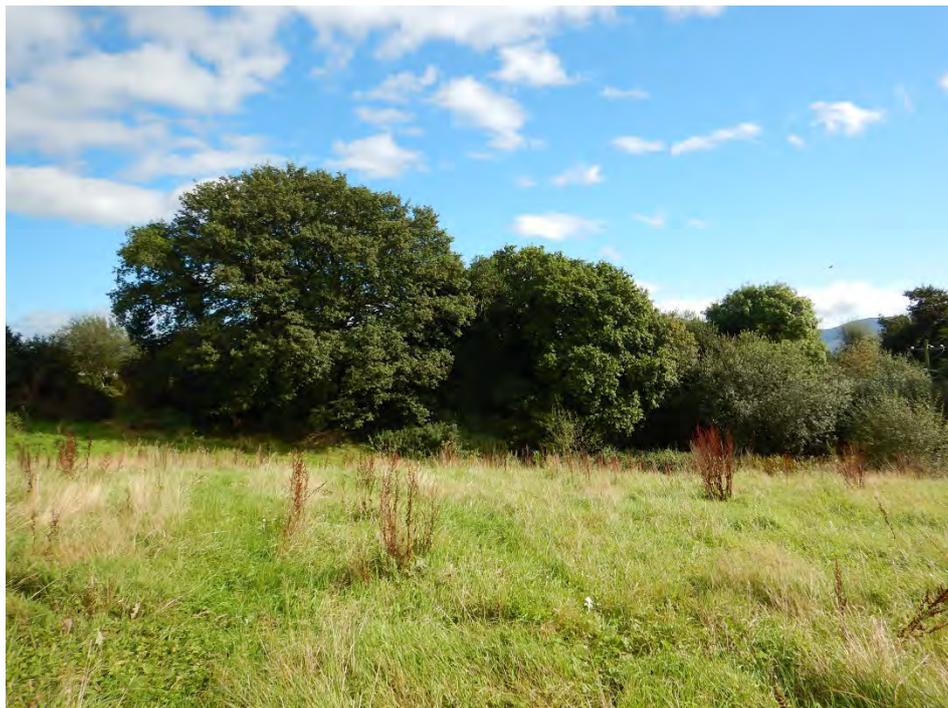
Photo 3. Trees T10-T15 along the hedgerow running along the eastern edge of the field

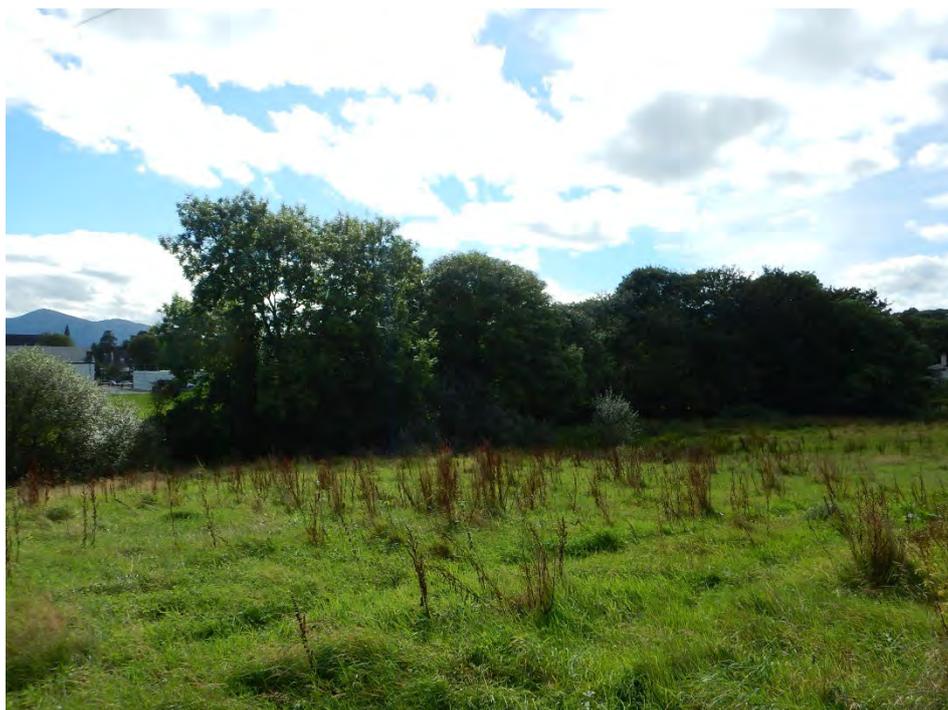
The trees labelled T16-T26 and the groups G1 and G2 are growing along the southern bank of the drainage ditch that follows the southern boundary of the site. The trees are of mixed species and include some Oak and Sycamore of moderate value; unfortunately, most of the Ash trees are showing signs of Ash dieback disease. These trees were mostly inaccessible from the site and tree size and condition was inferred from what visual access could be obtained.

Photo 4. Treeline extending along the southern boundary of the site (including trees T19-T30)

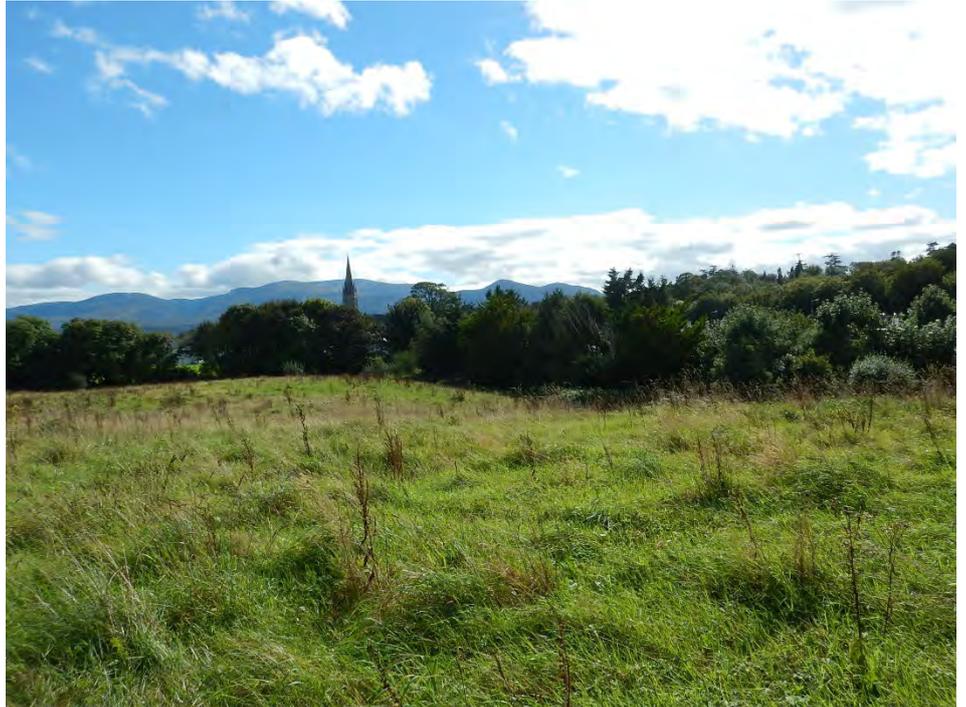
The rear gardens of the Port Cottages border the western edge of the site and include numerous (mostly exotic) trees and bushes (group G4) that together form a substantial landscape screen between the properties. Some of the coniferous trees appear to be in poor condition and require some management attention. Some young trees have been planted and others have become established by natural regeneration along the western edge of the field in the relatively recent past.

Photo 6. Western and southwestern boundary areas of site, with mixed conifers growing in the rear gardens of Port Cottages (Group G4) on the right and trees T19-T30 to the left of the cathedral spire
